THE DAMASCUS ROOM,
SHANGRI^{LA}

PHASE IV: FILLING AND
INPAINTING

LAUREN FAIR, WUDPAC 2010
LAURA KUBICK, WUDPAC 2010

Summer 2008

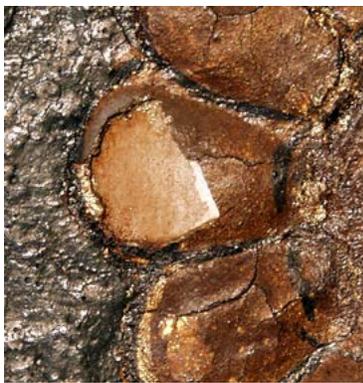
A) Losses in gesso elements

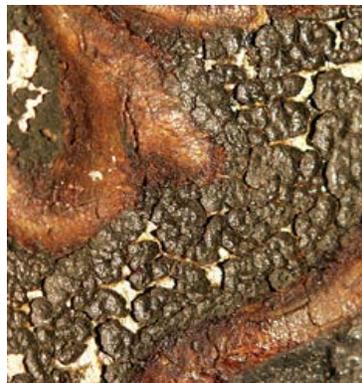
B) Losses in the paint layer

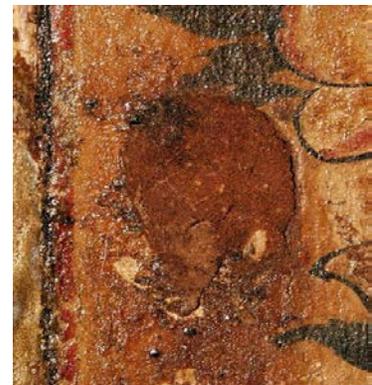
C) Mismatched brown fill material

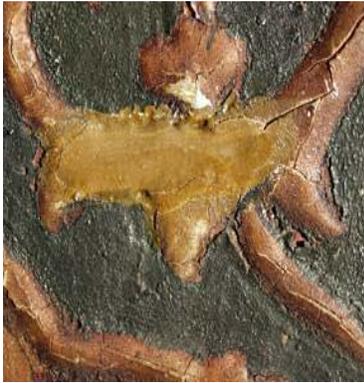
D) Mismatched hard tan fill material

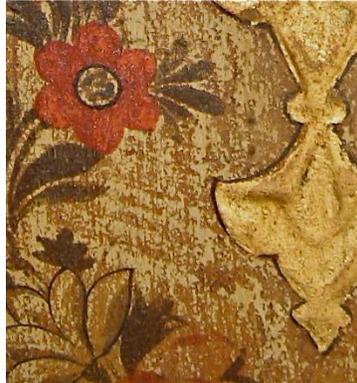
E) Abraded Varnish obscuring design motifs

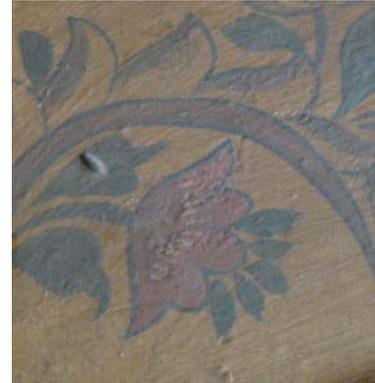
F) Cloudy Varnish obscuring design motifs

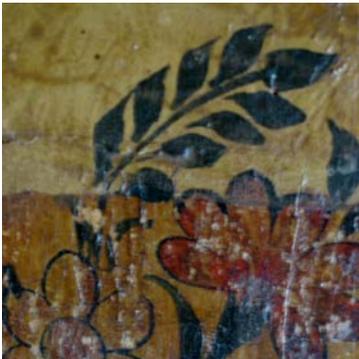
G) Two types of varnish abutting each other in the same panel

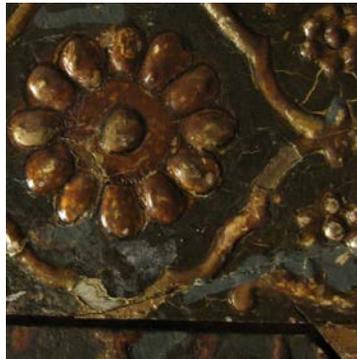
H) Mismatched blue overpaint

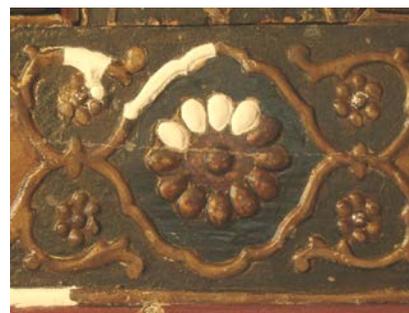
Detail of Mauka grid area C3 with fill material applied

The filling stage of the treatment was primarily carried out during the first week of the project. Large and distracting losses in *al ajami* decoration were filled using Modostuc diluted with water and applied with small sable brushes. After the Modostuc dried, the fills were shaped using water and cotton swabs, metal files and sanding sticks. Fills were only applied to losses on the walls that were at or below approximately seven feet from the ground, i.e. in areas easily detected from normal viewing height and distance.

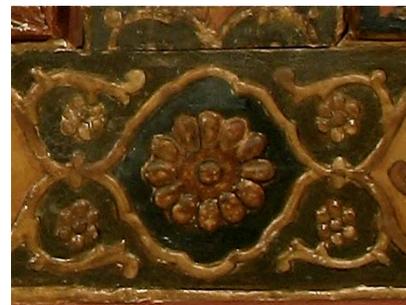
Detail of Mauka grid area C3 with inpainting the fill material

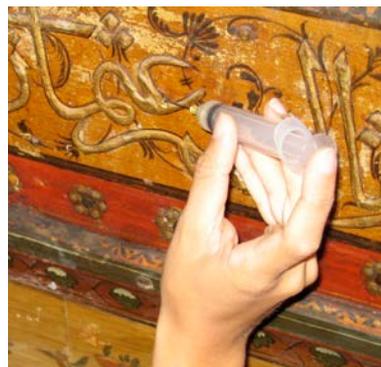
Consolidation of lifting gesso on Mauka Wall

During the course of the treatment, it was necessary to consolidate areas of flaking paint or gesso. There were only a few small areas that needed consolidation, primarily on the ceiling. A solution of Acryloid B-72 in acetone was used for consolidation of areas of flaking gesso. B-72 was chosen because it could be applied with a syringe and it set quickly enough so that work could be completed in a timely manner.

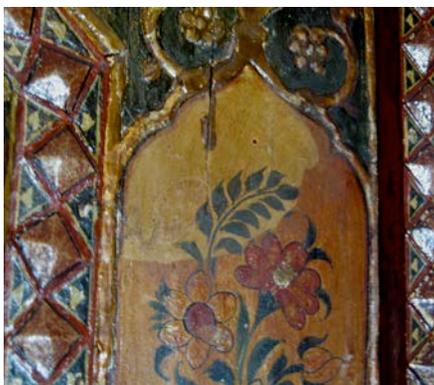
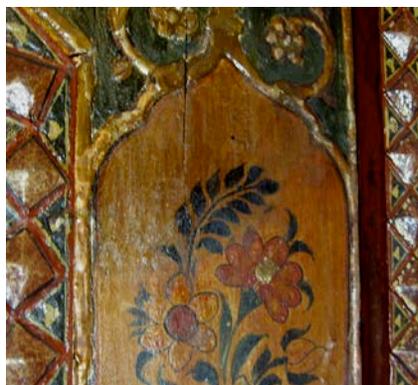
1. Some wall panels had later applications of coatings that covered only part of original material; these later coatings have darkened and were visibly different colors from the original coatings.

Detail of Diamond Head grid area B2 before toning

Detail of Diamond Head grid area B2 after toning

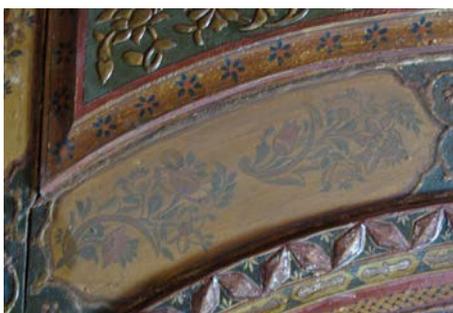
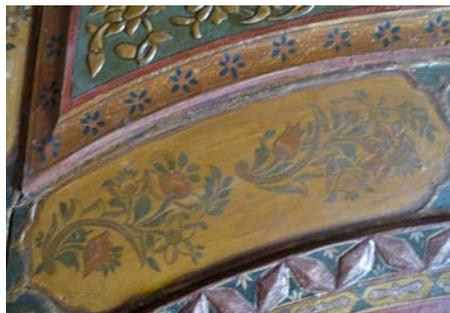
2. One panel on the Makai wall in particular had a cloudy varnish that did not match any other coating in the Damascus room. This was coated with Golden MSA varnish to reduce the cloudy appearance.

Detail of Makai grid area B1 during varnish application

Detail of Makai grid area B1 after saturating cloudy varnish

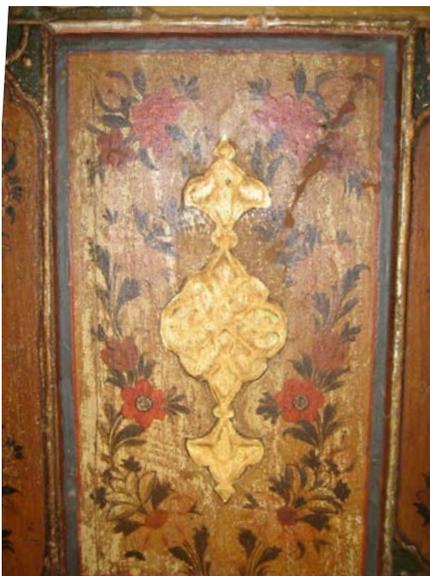
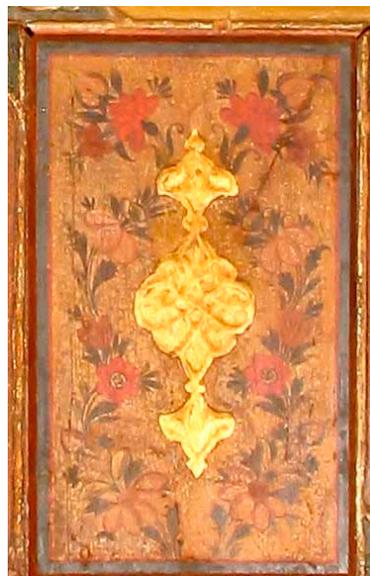
3. Coatings that were heavily abraded were inpainted, and varnish was applied to unify the overall appearance.

Panel in Koko Head grid area A3 before inpainting/varnish application

Panel in Koko Head grid area A3 after inpainting/varnish application

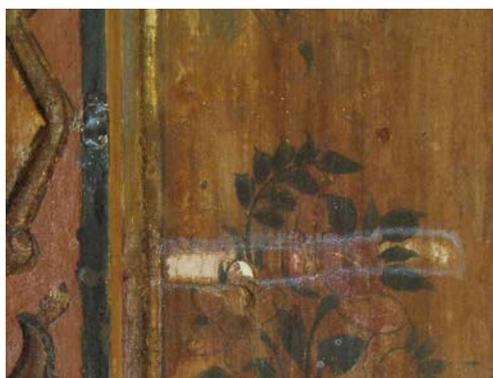
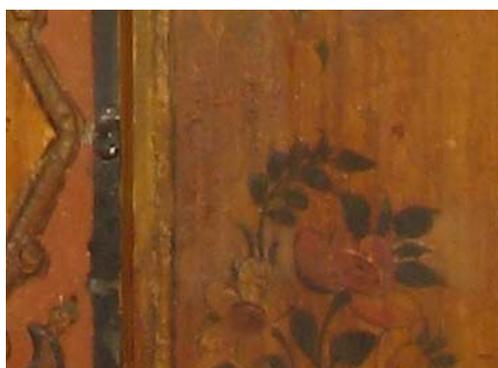
4. Three cleaning tests had been carried out in previous years. These are illustrated in the following grid sections: two in Mauka B2 and one in Koko B2. These areas were inpainted, and varnish was used to achieve the appropriate level of gloss. The inpainting of the cleaning test in the Koko Head B2 section is pictured here.

Cleaning test on Mauka grid area B2
before inpainting/varnish application

Mauka grid area B2 after
inpainting/varnish application

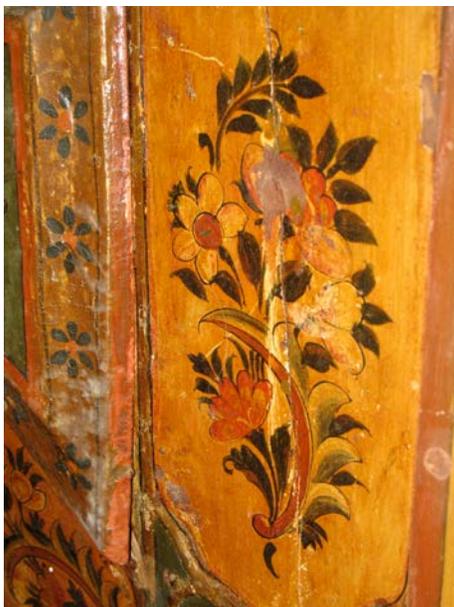
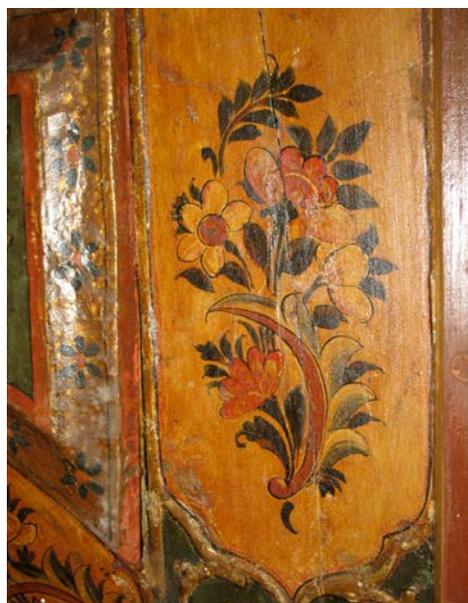
5. Cracks and losses were filled with Modostuc, a matte, water-reversible putty. Varnish was used in conjunction with PVA paints to achieve the appropriate level of gloss when inpainting these fill materials.

Detail of panel on Mauka grid section
B2 before inpainting/varnish
application

Mauka grid section B2 after
inpainting/varnish application
