THE DAMASCUS ROOM,
SHANGRI^{LA}

CONSOLIDATION &
DOCUMENTATION

LOUISE GROLL, WUDPAC 2009
BRET HEADLEY, WUDPAC 2009

Summer 2007

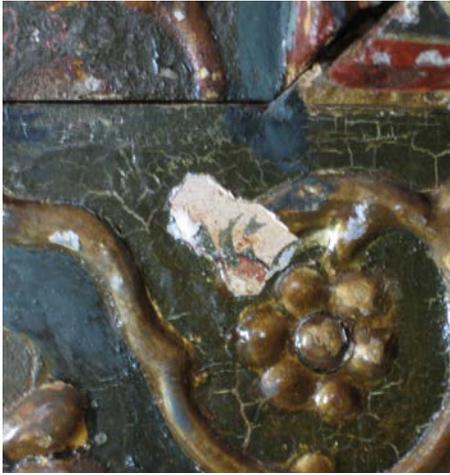
Underpainting of floral motif seen in loss. Located on new panel. By Asfar & Sarkis?

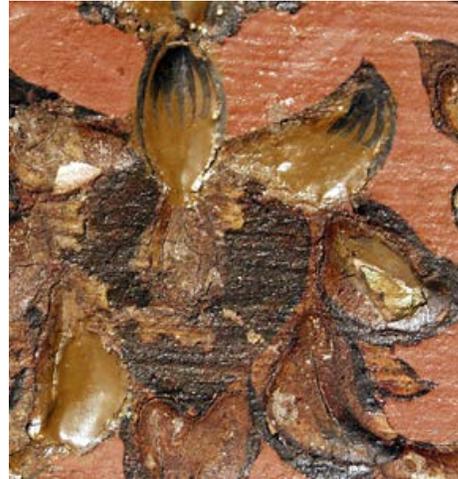
Glossy brown fill material. By Doris Duke?

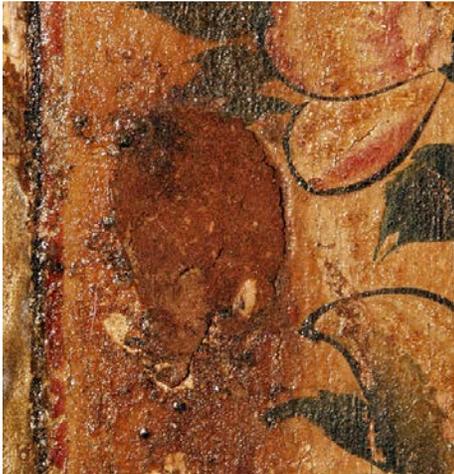
Coarse Red Putty Fill.

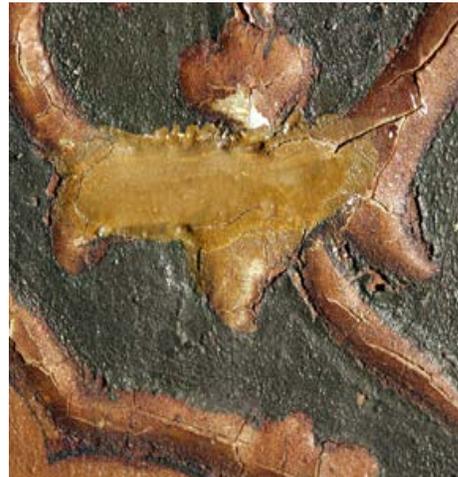
Glossy Caramel-like fill. By Doris Duke?

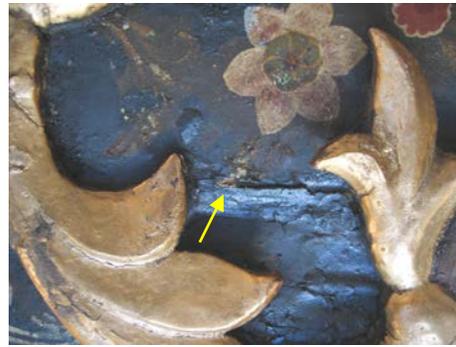
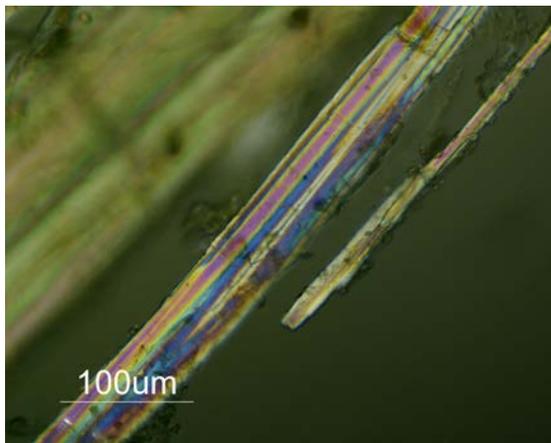
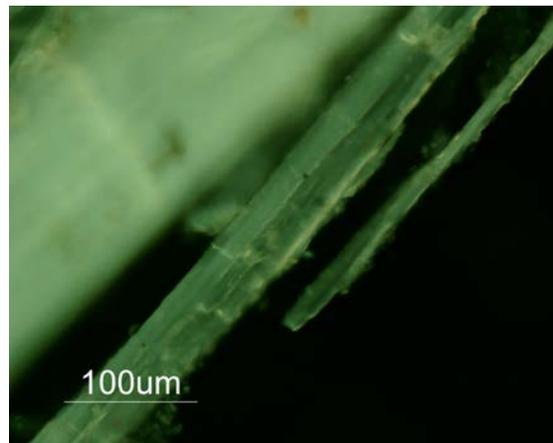
Sample Number: 49
Sample date: July 5, 2007
Elevation: Ceiling D3
Decorative element: fiber-fill
between boards
Sampled by: Louise Groll
Examined by: Richard Wolbers

100x Visible light

100x Violet

Results: Bast fiber such as hemp or flax.

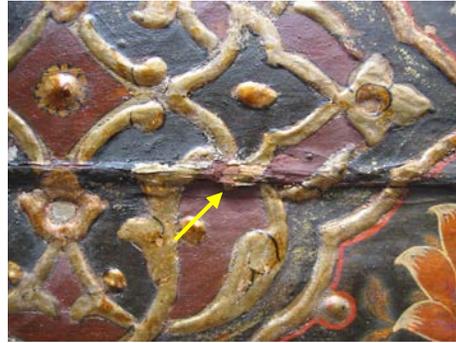
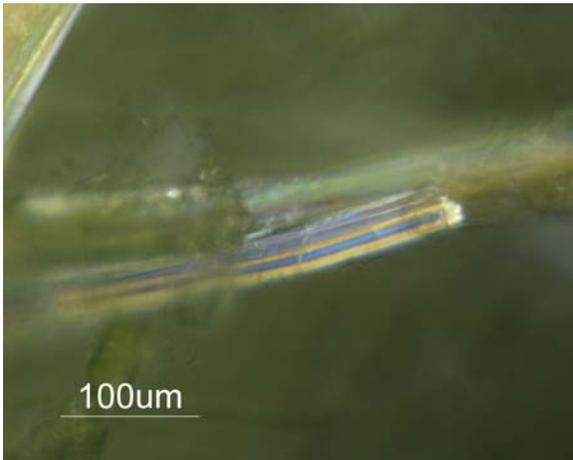
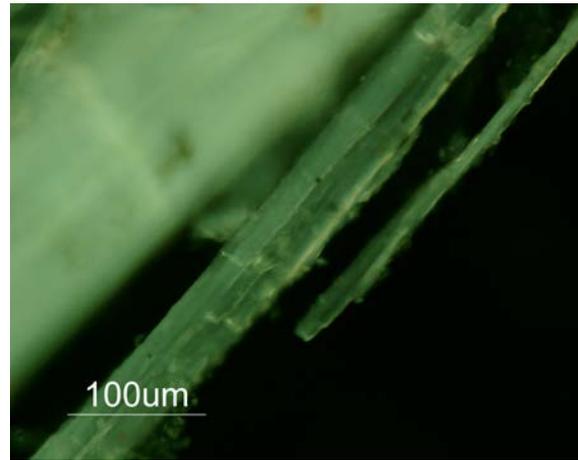
Sample Number: 50
Sample date: July 5, 2007
Decorative element: fiber-fill
Between boards
Elevation: Ceiling E1
Sampled by: Louise Groll
Examined by: Richard Wolbers

100x Visible light

100x Violet

Results: Bast Fiber such as hemp or flax.

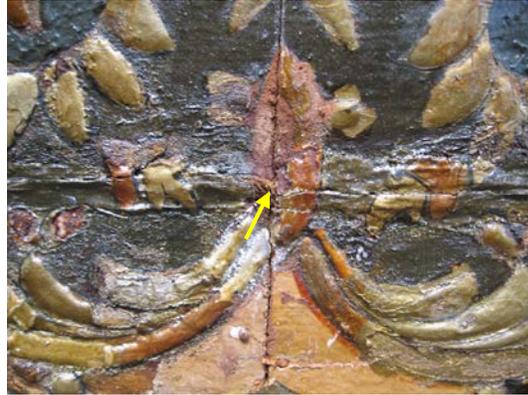
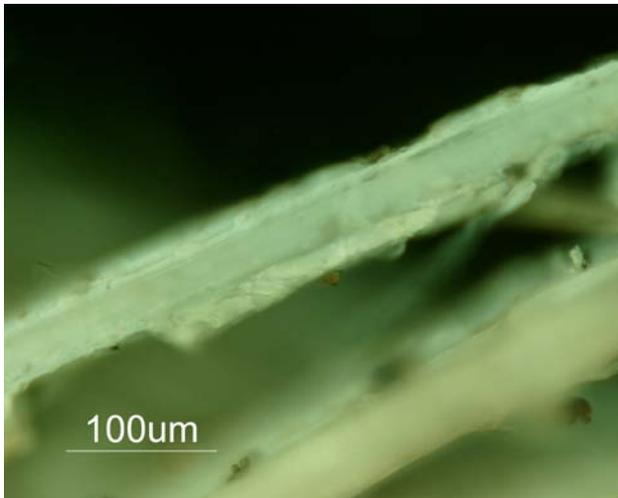
Sample Number: 51
Sample date: July 5, 2007
Decorative element: fiber-fill
between boards
Elevation: Ceiling D2
Sampled by: Louise Groll
Examined by: Richard Wolbers

100x Violet

Results:
Bast fiber such as hemp or flax

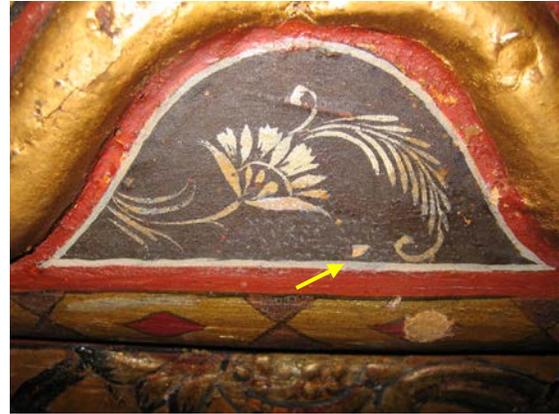
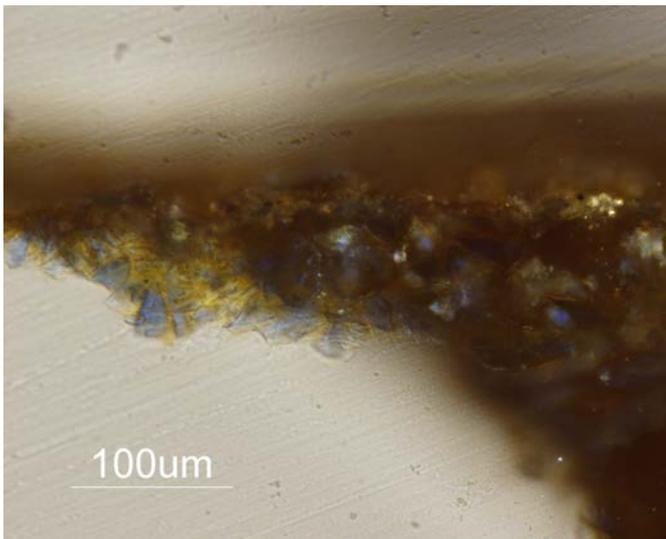
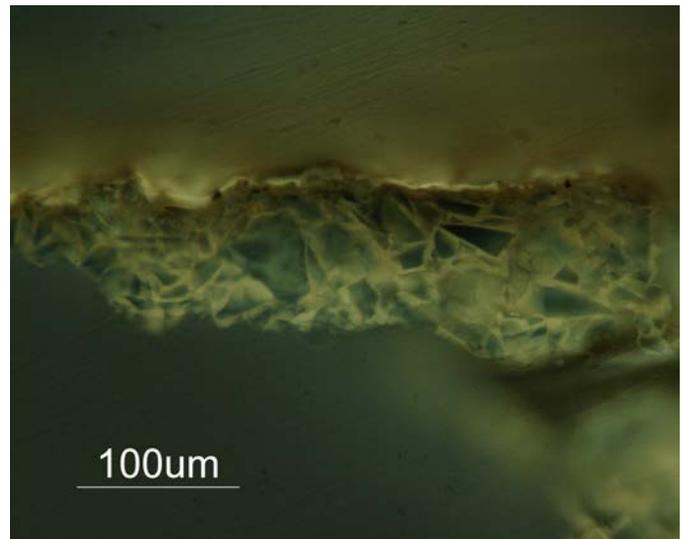
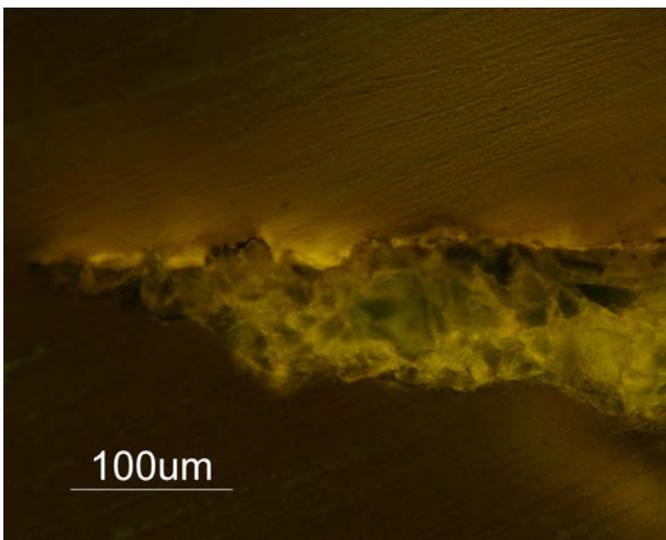
Sample Number: 52
Sample date: July 5, 2007
Decorative element: White bloom (mold?)
Elevation: Ceiling C2
Sampled by: Louise Groll
Examined by: Richard Wolbers

100x Visible light

100x Violet

100x blue Lectin FITC

RESULTS:
Stained positive for mold.

A white mold was found to be present on areas of dark paint on the ceiling. These areas were cleaned using mineral spirits applied with a lint-free cotton pad. This treatment removed the mold growth, but did not kill or remove mold spores. It is important to note that given the right environment these spores will continue to grow.
